# Hot Indium Seal Status and Plans

Andrey Elagin  
University of Chicago

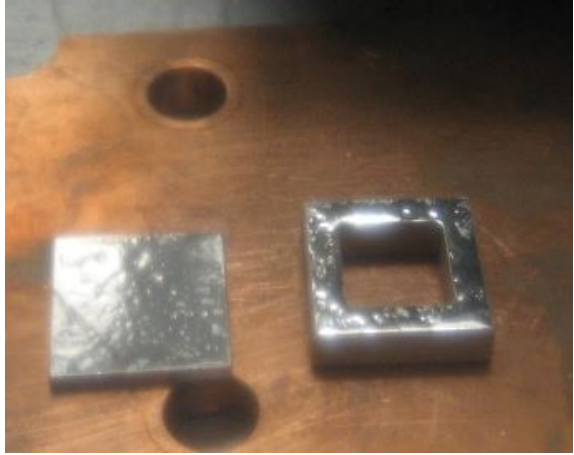
**Step 1:**  
apply **melted** indium  
to the glass parts

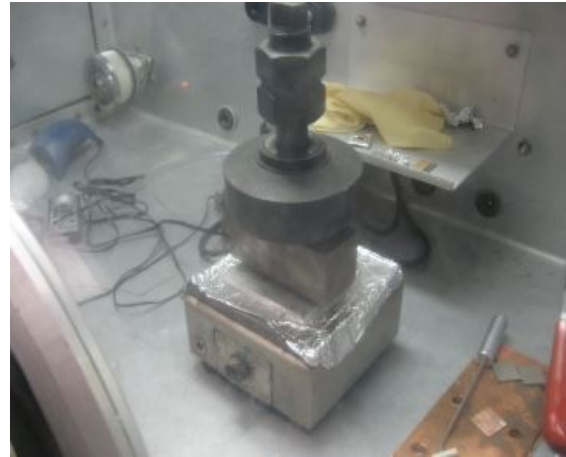
**Step 2:**  
bring parts into contact and press

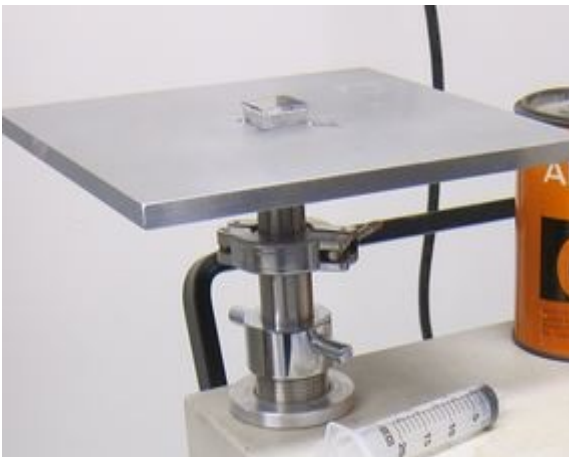
**Step 3:**  
pump from open side  
and leak check

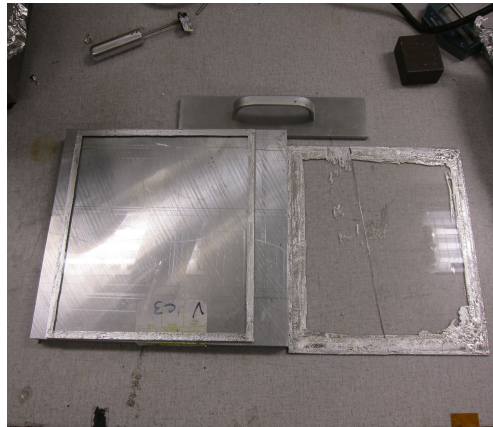
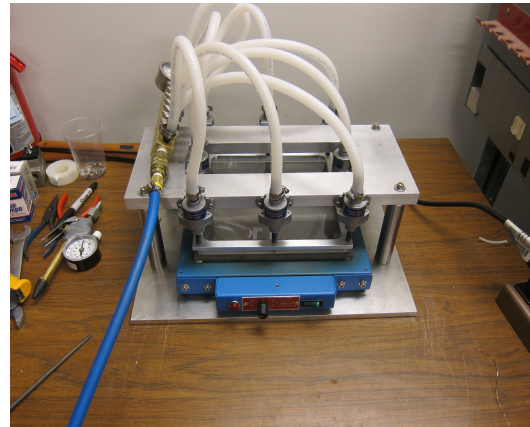
# Phase I (in air)

- **Indium seal fundamentals**
  - interface (good adhesion of indium to the glass surface)
  - oxide formation
- **Proof of principle using 1x1" test samples**
  - little oxidation (assembly is fast)
  - many successful **reproducible** leak tight samples
- **Several (>10) attempts to make 8x8" seal**
  - oxide formation becomes limiting factor (slow assembly)
  - best result is a part with  $10^{-6}$  cc/s leak at a single pinpoint

...indium oxidizes quickly...

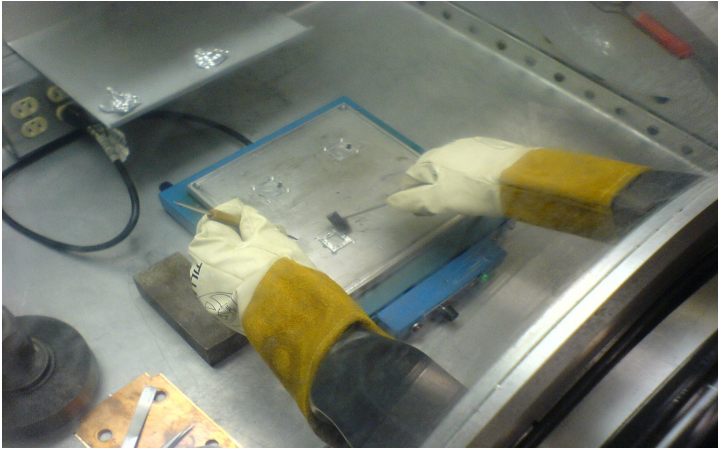
**Nitrogen filled glove box:**

**O<sub>2</sub> and H<sub>2</sub>O concentration ~5ppm**

...indium doesn't stick to glass if no O<sub>2</sub>...

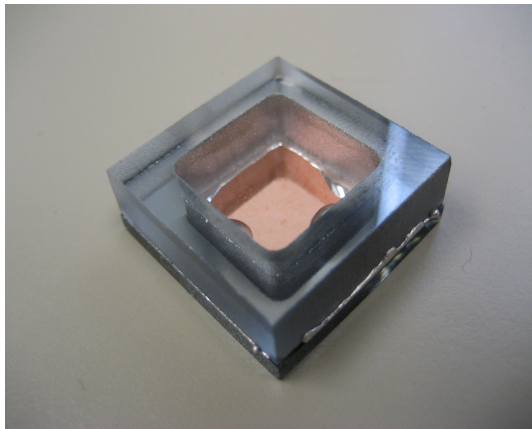
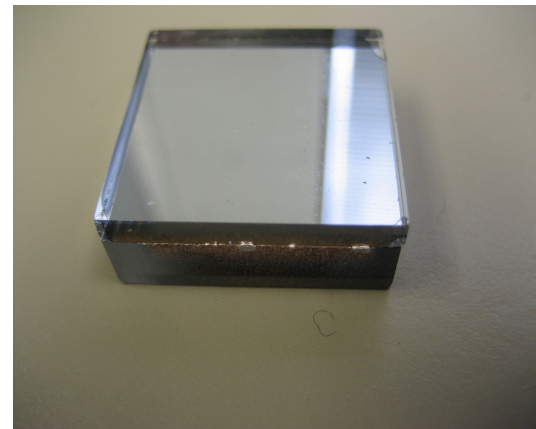
# NiCr-In Seal Results (1" parts)

**Total 8 small size seals made: 5 are leak tight**

3 have leaks (oxidation of Cu surface or electroding peeling off the glass)

Bare glass #1	190 lbs
Bare glass #2	278 lbs
Bare glass with groove	268 lbs
<b>Cu coated glass #3</b>	<b>390 lbs</b>
<b>Cu coated glass #4</b>	<b>345 lbs</b>

Bare glass #4	47 lbs
Cu coated glass #1	213 lbs
Cu coated glass #2	221 lbs

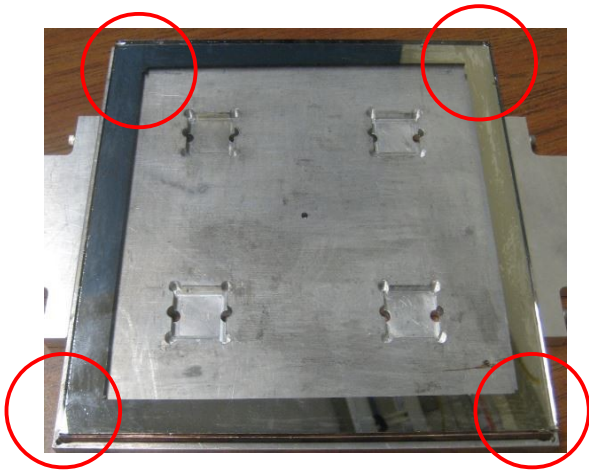
Copper surface got oxidized before contact with indium:  
- parts held in air after coating  
- poor indium wetting observed

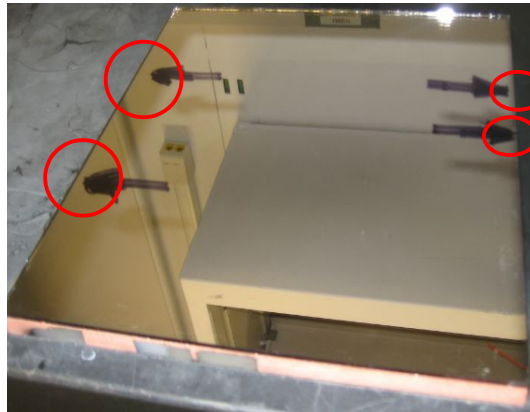
Under investigation  
- sidewall sat in air between NiCr and Cu depositions  
- non uniformity in compression?

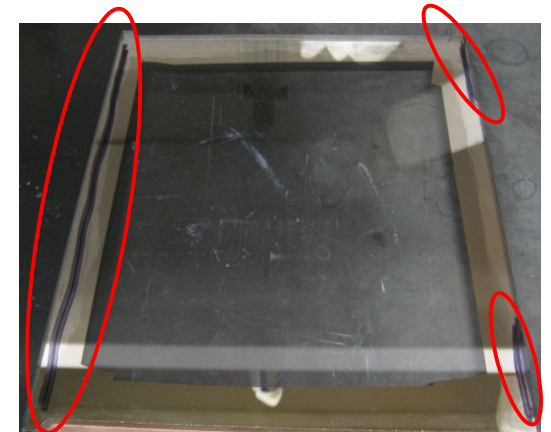
Under investigation  
- coating non-uniformity  
- small size gun used for Cu  
- compression problem?

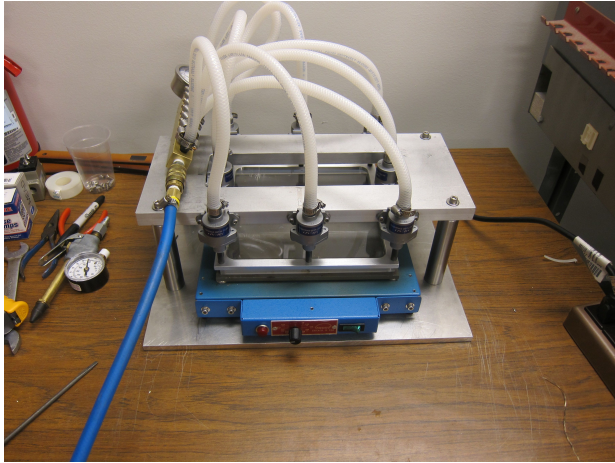
**In the air**

Capable of 80lbs at 8 points  
Normally was used at 30lbs

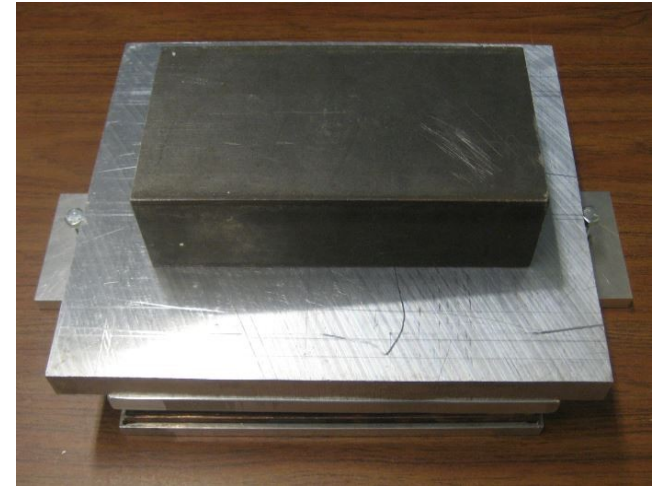
**In the glove box**

Pile of bricks up to 50lbs

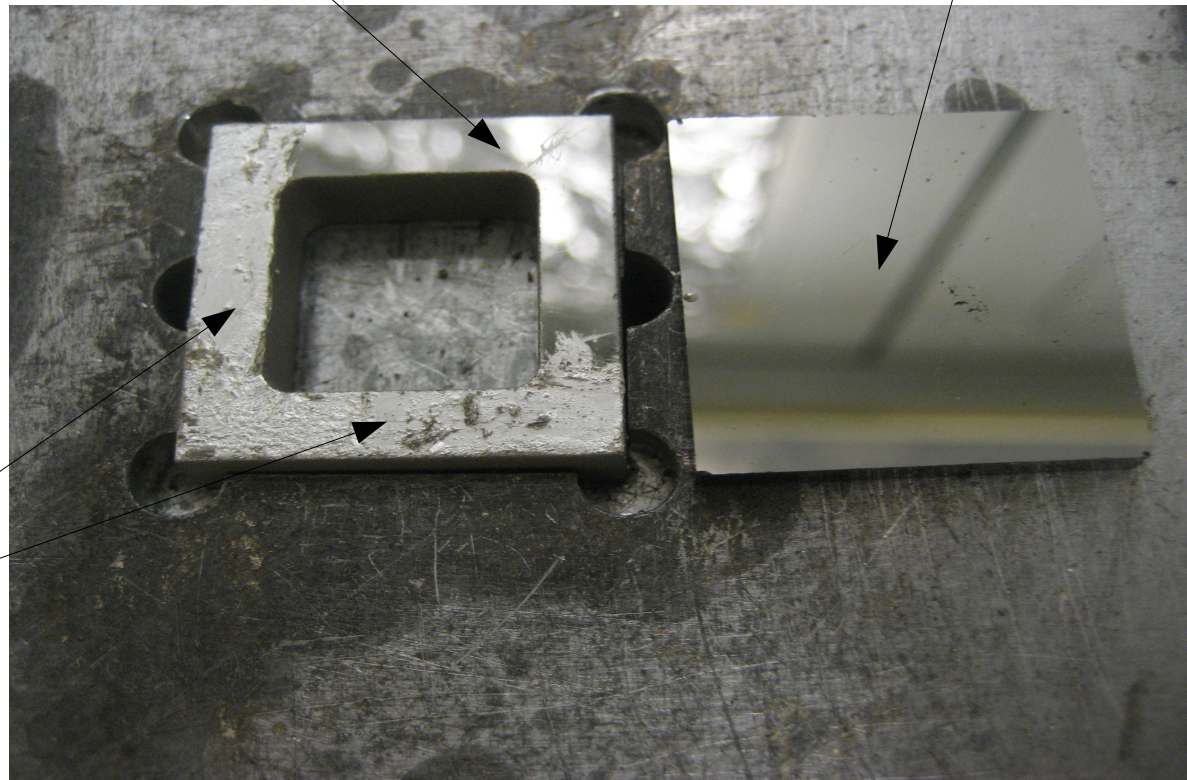
# Before vacuum bake but after heating at 300C in air for an hour

NiCr with ~20nm indium sputtered on top

NiCr only

Extra indium applied

**This step was done to make sure that  $\text{In}_2\text{O}_3$  is definitely there before vacuum bake**

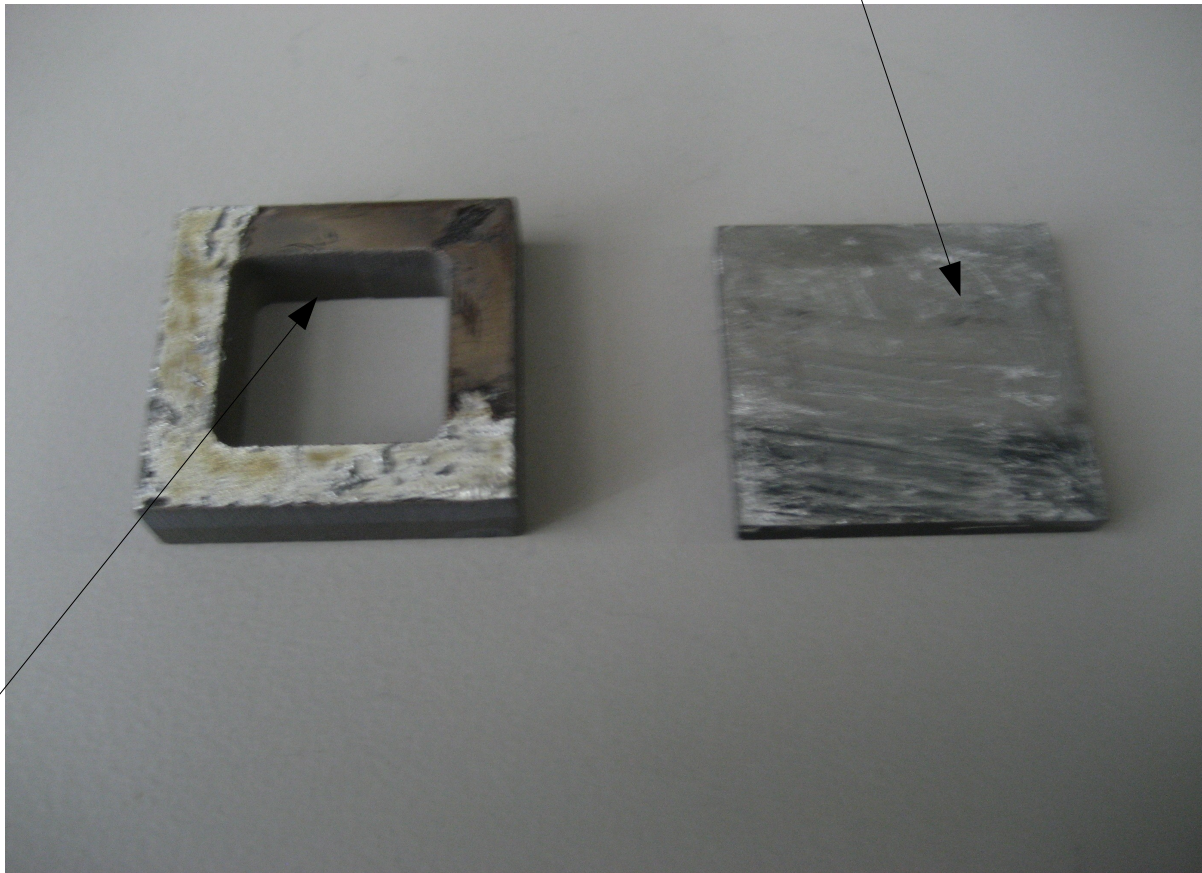
# After 16hrs bake @ 400C & $\sim 10^{-6}$ mbar

This is different sample:  
bare glass with quick tinning of indium without extensive  
heating in air prior to vacuum bake.  
Stayed unchanged after vacuum bake

Same sample as on previous slide  
Many brown spots after vacuum bake
